# Southern States EV2 Switch Bearing

Replacement, Refurbished & Upgraded

FEATURED CASE STUDY  
EV2 Bearing Refurbishment  
& Upgrade

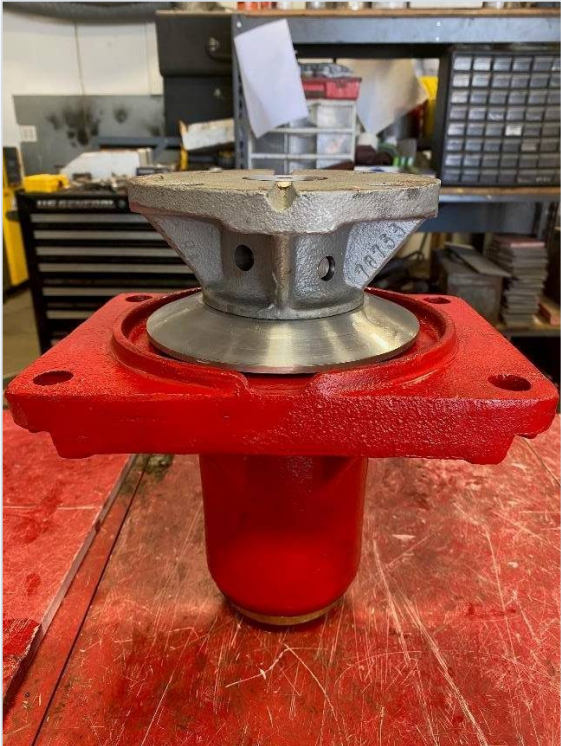
*The original aluminum-against-steel EV2 bearing corrodes and seizes in Florida's humidity.*

We rebuild it in-house: 316 stainless shaft, sealed stainless ball bearings, machined brass lock nut, and Viton O-ring seals in place of the original felt gasket. The rebuild eliminates all three original failure mechanisms, galvanic corrosion at the lock nut, moisture ingress into an open bearing, and a felt seal that wicks water instead of blocking it, and outlasts the original design in service.

Aluminum lock nut against steel shaft, replaced with machined brass

Open-race bearing replaced with a sealed unit

Dry felt wicks water onto the bearing; replaced with a Viton O-ring
